**SERVICE BULLETIN SB FSG2T-1.05**

**TYPE DESIGNATION** FSG 2T VHF/AM Airband Transceiver – Part number F10350

**APPLICABILITY** This Service Bulletin may be introduced to all FSG 2T VHF/AM transceivers having serial number 35X-05100 up to serial number 35X-06493, or marked with Mod-Index **SB 1.05**.

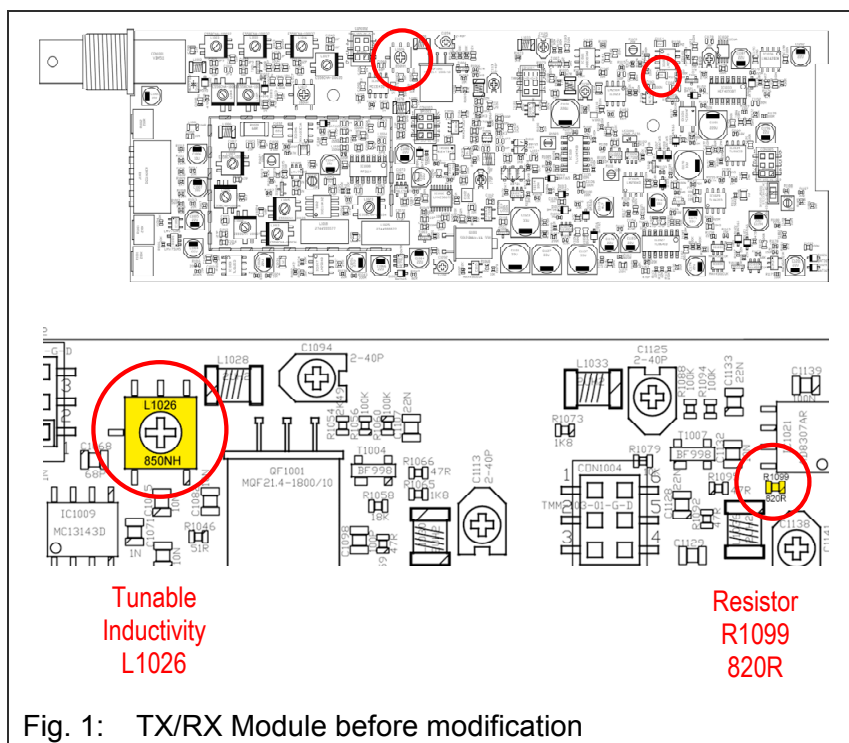
Fig. 1: TX/RX Module before modification

**REASON** In the direct vicinity of strong external RF transmitters, which exceed the limits of transmitted signal levels specified as maximum, could disturb communication by suppression of the active channel.

Locate the resistor R1099 (820R) and the tunable inductivity L1026 on the TX/RX Module.

Repair: Replacing the Resistor R1099/820R by a Resistor R1099/150R:

- Use an adequate solder tip to unsolder the 820R Resistor.
- Clean the soldering pads.
- Take the supplied NEW Resistor R1099, 150R, and position it.
- Use an adequate solder tip and solder.
