**SERVICE BULLETIN SB FSG2T-1.06**

**TYPE DESIGNATION** FSG 2T VHF/AM Airband Transceiver – Part number F10350

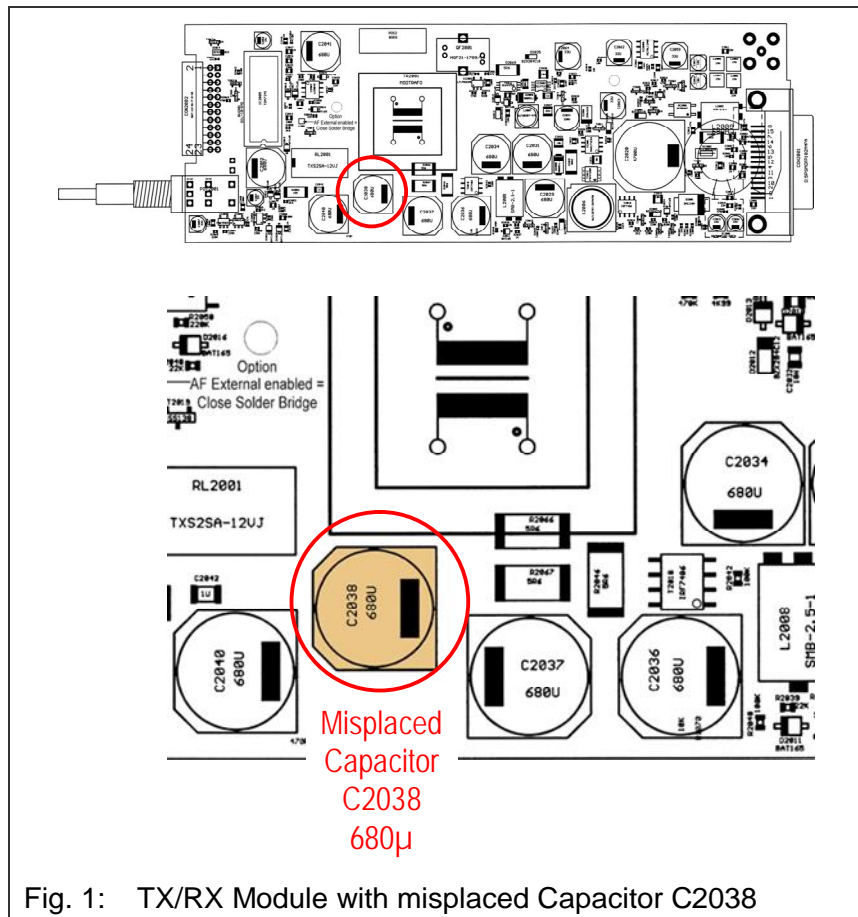
**REASON** Possible degradation of operational availability could create disruption of VHF communication due to internal capacitor misplacement. The capacitor could be destroyed and could be separated with possible generation of smoke.

Locate the misplaced capacitor C2038 (680µ) on the TX/RX Module.

Fig. 1: TX/RX Module with misplaced Capacitor C2038

- Repair:
- An adhesive fixes the capacitor C2038. Use a regulated heat gun (ca. 300°C / 570°F) with a small nozzle to warm up the adhesive.
  - Scratch off the adhesive.
  - Use an adequate solder tip to unsolder the misplaced capacitor.
  - Clean the soldering pads.
  - Take the supplied NEW capacitor C2038, 680µ and position it (watch polarity/marker!).
  - Solder.

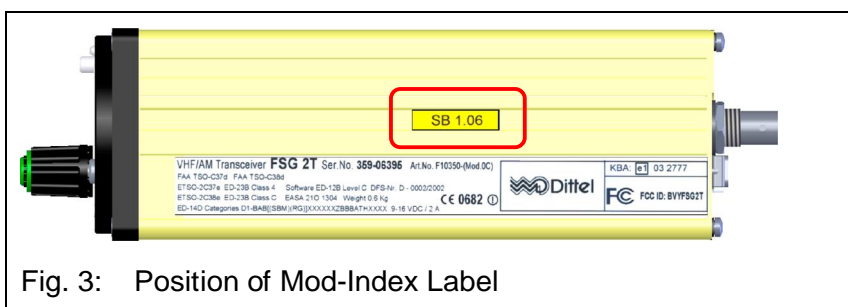
Fig. 3: Position of Mod-Index Label

After meeting the required minimum performance values mark the transceiver FSG 2T with the supplied Mod-Index label
